RE: Structural Evaluation Observations and Recommendations of the Kaleidoscope School Building at 520 W. Wood St. in Decatur, Illinois.

On June 1, 2023, Structural Engineer Kyle Hannel, P.E. of Klingner & Associates performed a visual structural evaluation of the Kaleidoscope School Building at 520 W. Wood St. in Decatur, Illinois. We were informed that there were recent concerns with the structural integrity of the original building's exterior walls and parapets. The focus of our inspection and evaluation was limited to the exterior walls and parapets of the Kaleidoscope School building. The original 3-story portion of this school building was built in 1913 and was named New Wood Street School. In the 1970's and 1980's 2-story additions were added to the east and west side of the original school building and was named French Elementary School. Access to the existing building plans that the school district had available were made available to us to scan so we could have a copy to aid in our evaluation just prior to performing our inspections. We have included scans of a couple of important applicable drawings as attachments to this report. The Decatur Public School District had re

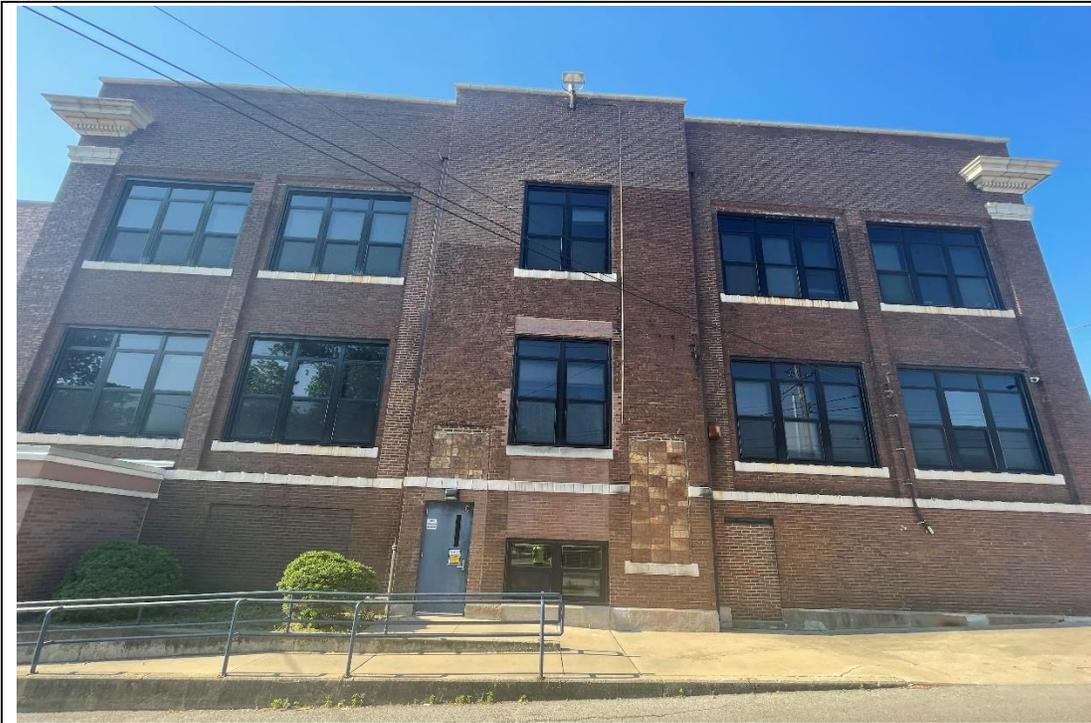
construction. However, it appears most of the third-floor window lintels have signs of pack-rusting and deterioration. Pack rust occurs when steel is exposed to water over a long time and starts to rust. The long-term rust expands and pushes against adjacent building materials. No signs of settlement cracking in the exterior walls or exposed portion of foundation of the 3-story building was observed. The only signs of brick or mortar joint cracking observed were near deteriorated window lintel bearings or near the tops of the 3-story walls at the corners or wall bump-outs. See attached Photos #1 thru #7 and #10 thru #14.

Description	Photo showing north wall exterior elevation of original 3-story building. Note portions of the wall has already had previous tuck-pointing repairs.	<b>1</b>
Date	06/01/2023

**Klingner recommends repairing or replacing all pack-rusting deteriorated window lintels and tuckpointing all deteriorated brick mortar joints.**

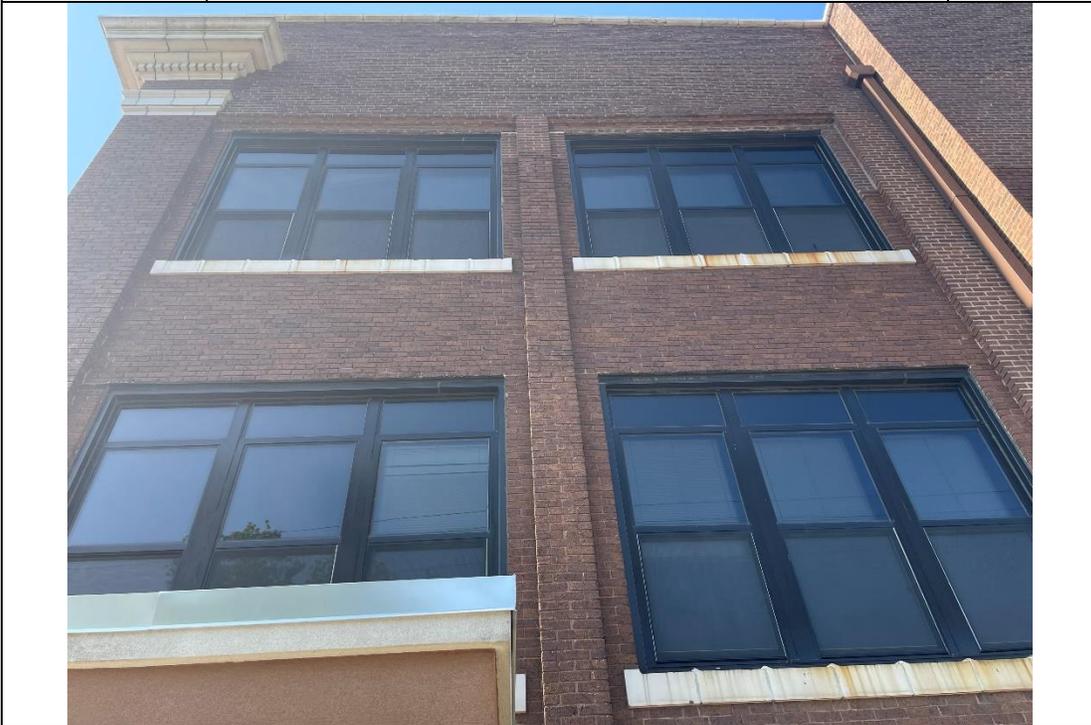
Description	Photo showing that it appears 2 <sup>nd</sup> floor window lintels have been repaired/replaced in the past but 3 <sup>rd</sup> floor lintels are pack-rusting and have not been repaired/replaced.	<b>2</b>
Date	06/01/2023

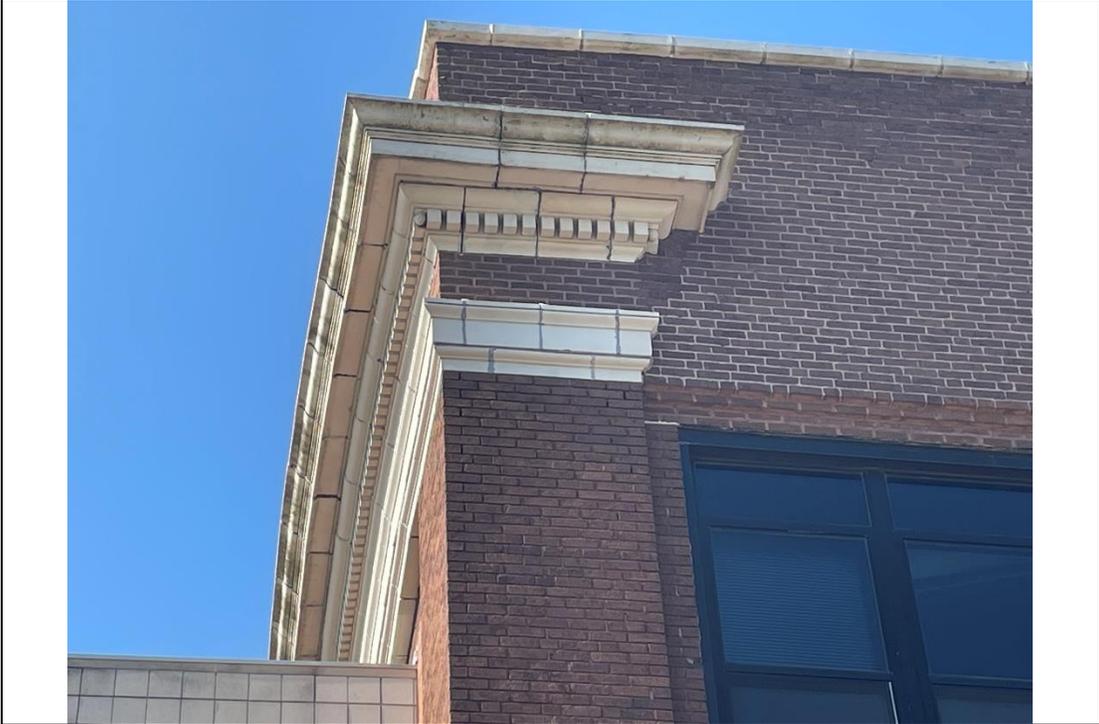
2. The east and west exterior walls of the 3-story school building showed signs of bowing and leaning out starting near the third-floor ceiling elevation going up. This elevation is similar to where the interior load-bearing brick walls that run at third points in the east west direction stop and where the 2-story additions on the east and west side of the original school building have their roofs and top of walls tie in. There is more wall bowing and leaning on the east wall than the west wall. See attached Photos #3, #5, #7, and #10 thru #14.

Description	Photo showing north-east corner of exterior side of parapet showing the bow in the top of wall and the separation and displacements of the terra cotta decorative overhang blocks.	<b>3</b>
Date	06/01/2023

**Klingner recommends partial demolition and rebuild of the top of the east wall and parapet. While rebuilding the top of east wall Klingner recommends considering not putting back the decorative terra cotta cantilever strip portions of wall and only using brick or cmu block with brick veneer. The terra cotta can be reinstalled if proper reinforcement is provided, but this would be more costly. Klingner also recommends using tie-back anchors to secure the east exterior wall back to adequately braced and blocked roof framing. For the west exterior wall Klingner is Not currently recommending partial demolition or rebuilding of the top of the west wall or parapet, but Klingner does recommend using tie-back anchors to secure the west exterior wall back to adequately braced and blocked roof framing.**

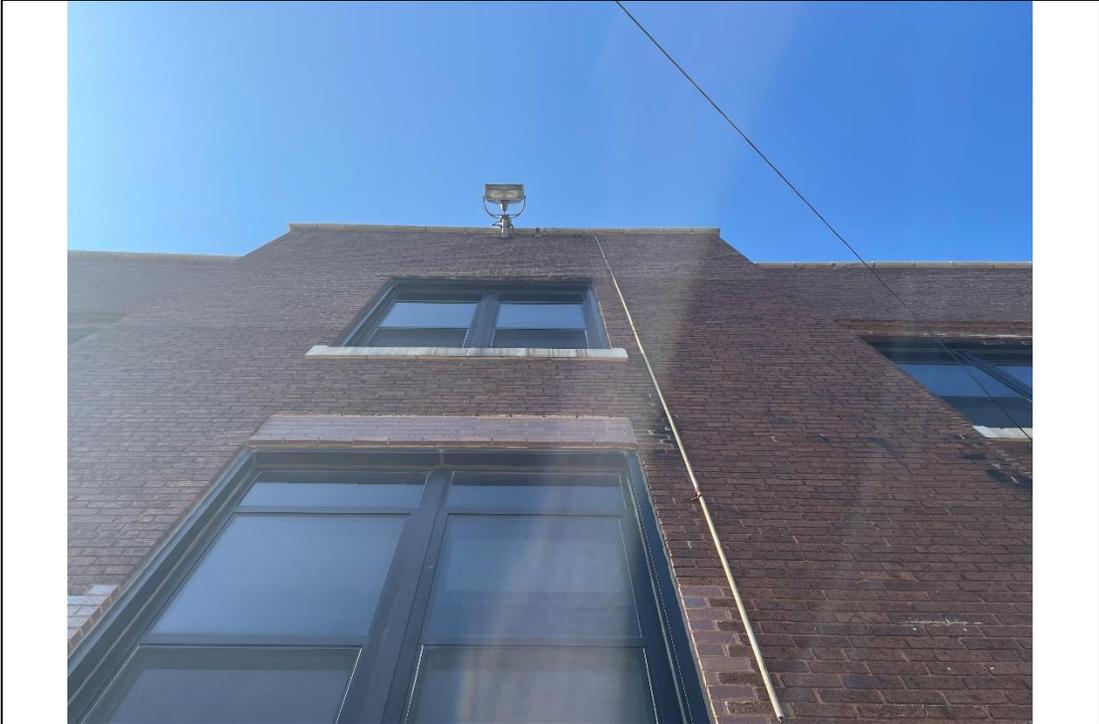
Description	Photo showing that it appears 2 <sup>nd</sup> floor window lintels have been repaired/replaced in the past but 3 <sup>rd</sup> floor lintels are pack-rusting and have not been repaired/replaced.	<b>4</b>
Date	06/01/2023

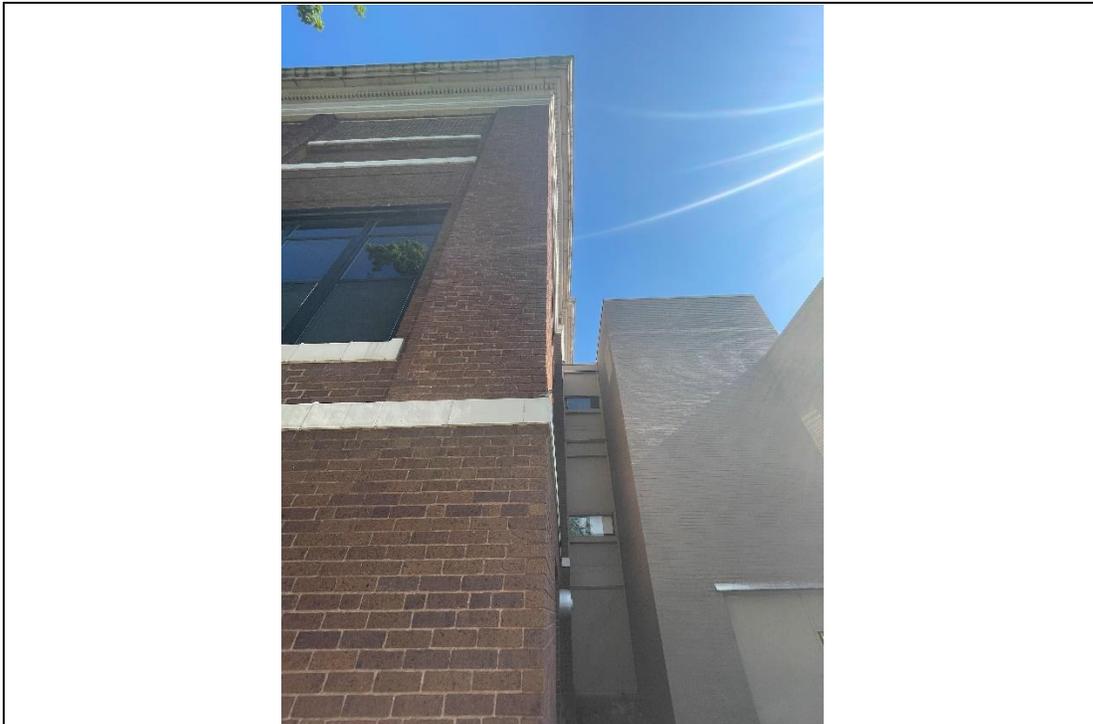
4. The exterior walls parapets of the original 1913 3-story school building are made up of multi-wythe brick parapets with portions of large terra cotta decorative block strips cantilevered out on the exterior side of the parapets. The parapets have a terra cotta cap stone. The top of parapet height above the roof line ranges from 3'-0" to 6'-6" above the roof level. The roof membrane flashes into the lowest course of brick exposed above the roof membrane and ballast and the flashing steps down to approximately follow the slope of the roof line. The inside face of parapet appears to have been coated and painted to attempt to prevent moisture infiltration of the parapet. However, the coating and paint on the inside portion of parapet is deteriorated and missing in numerous locations and appears to be allowing moisture to penetrate the parapet walls. Moisture damage to the drywall near the top of wall or ceiling tiles near the exterior wall in multiple third floor classrooms was observed. The deterioration of the paint and moisture coating appears to be the worst near the roof drain scuppers on the north parapet. Cracks were observed on the interior side of the north-east and north-west parapet corners. The north-east parapet corner cracks were larger than the north-west parapet corner cracks. The parapets are leaning outward and bowing outward in multiple locations. The worst of the parapet bowing and leaning observed was along the east parapet and specifically the north end and corner of the east parapet. The west and north wall parapet bowed outward near the quarter points. The south wall parapet was the shortest parapet and showed the least signs of leaning or bowing. See attached Photos #1 thru #7, #10 thru #23, and #34.

Description	Photo showing south-east corner of exterior wall showing the bow in the top of wall and the separation and displacements of the terra cotta decorative overhang blocks.	5
Date	06/01/2023

**Similar to exterior wall Observation #2 above, Klingner recommends partial demolition and rebuild of the top of the east wall and parapet. While rebuilding the top of east wall Klingner recommends considering not putting back the decorative terra cotta cantilever strip portions of wall and only using brick or cmu block with brick veneer. The terra cotta can be reinstalled if proper reinforcement is provided, but this would be more costly. Klingner also recommends using tie-back anchors on both the east exterior wall and west exterior wall to tie the walls back to adequately braced and blocked roof framing.**

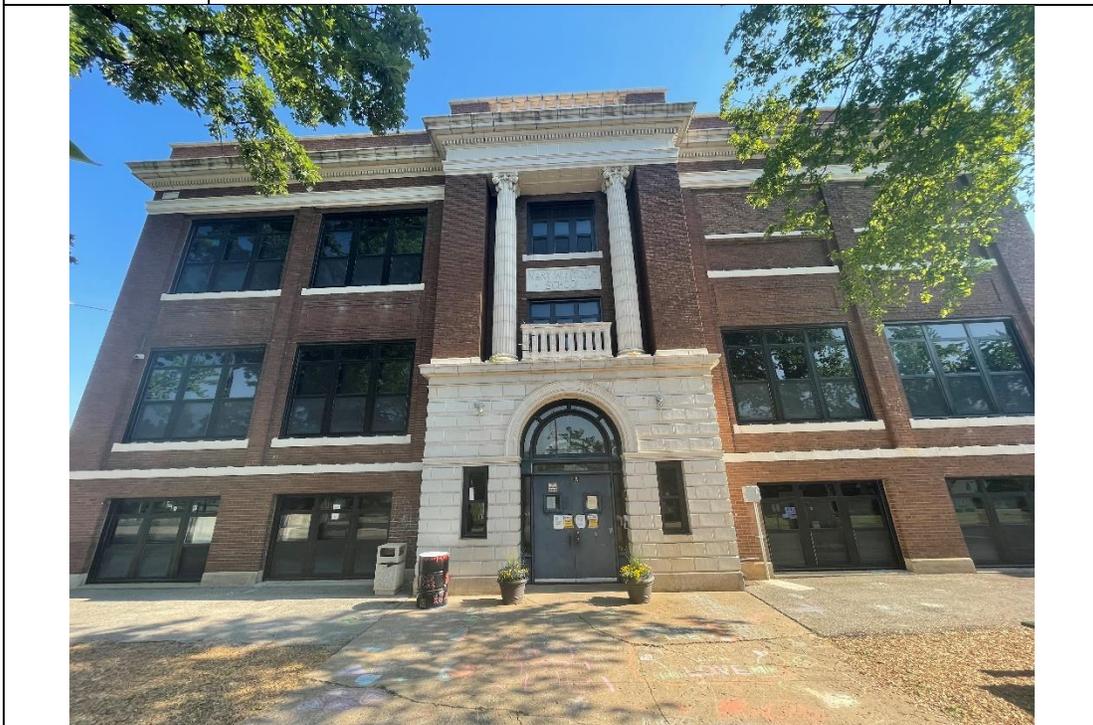
Description	Photo showing south wall exterior elevation of original 3-story building. Note portions of the upper wall and parapet has already had previous tuck-pointing repairs.	6
Date	06/01/2023

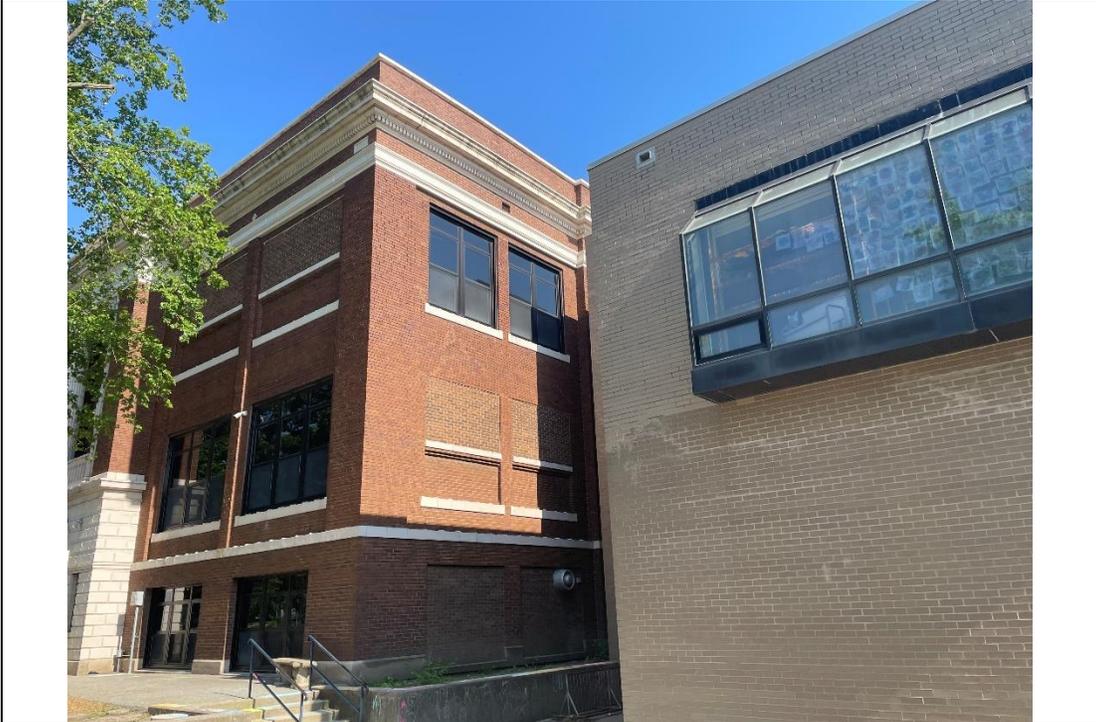
Description	Photo showing south-east corner of exterior wall showing the bow in the top of wall and terra cotta decorative overhang blocks.	<b>7</b>
Date	06/01/2023

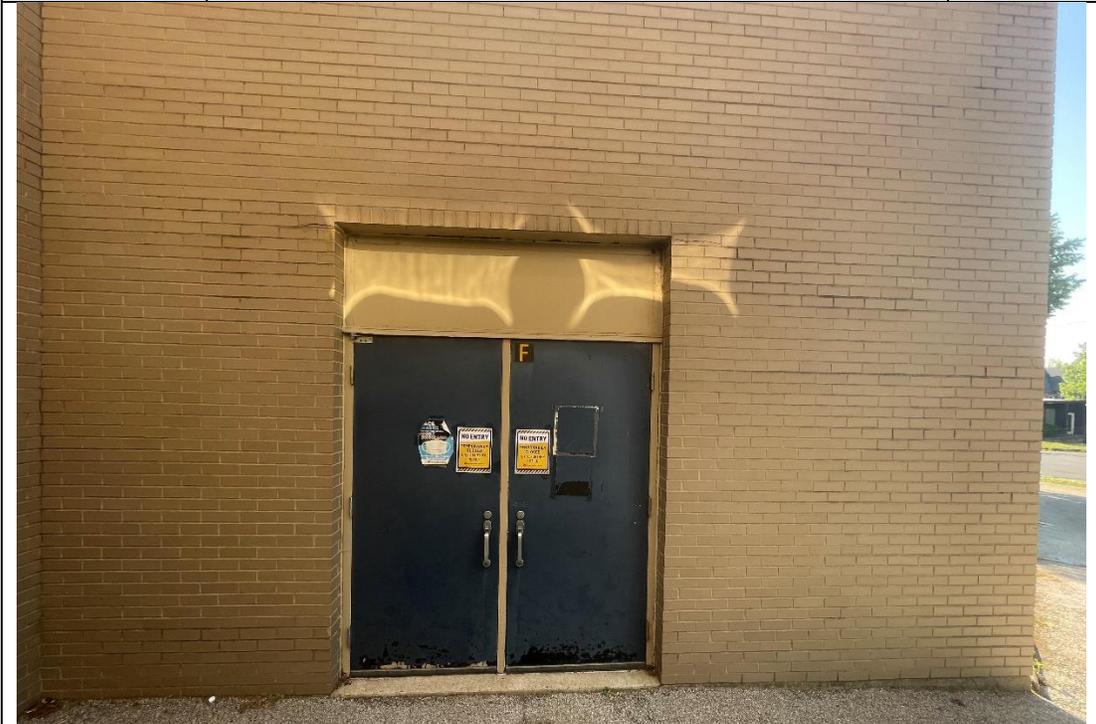
3. While the focus of the evaluation was on the original 3-story school building, we also observed a few locations of exterior wall deterioration on the 2-story east building addition. Two exterior wall door openings on the first floor near the south-west portion of the east building had lintels with pack-rusting deterioration that had cracked the brick veneer at each end of the lintel bearing. Similarly, there is a large lintel beam for an opening on the west side of the roof-top screen wall that surrounds the east addition roof top equipment that has severe pack-rust deterioration and brick veneer deterioration at the lintel bearing. The upper courses of concrete masonry unit (cmu) block and brick veneer of the east roof-top screen walls have mortar joint cracking that stair steps near the wall corners and lintels bearings. See attached Photos #8 thru #9 and #24 thru #25.

Description	Photo showing pack-rusting lintel above an existing east addition near the south-east corner man door opening that has cracked the brick at each side of the lintel.	<b>8</b>
Date	06/01/2023

**Klingner recommends repairing or replacing all pack-rusting deteriorated door opening lintels in the east addition exterior walls and roof top screen wall and tuckpointing all deteriorated brick and cmu mortar joints. Klingner recommends using galvanized steel lintels if replacing the door lintels to prevent future pack-rusting deterioration.**

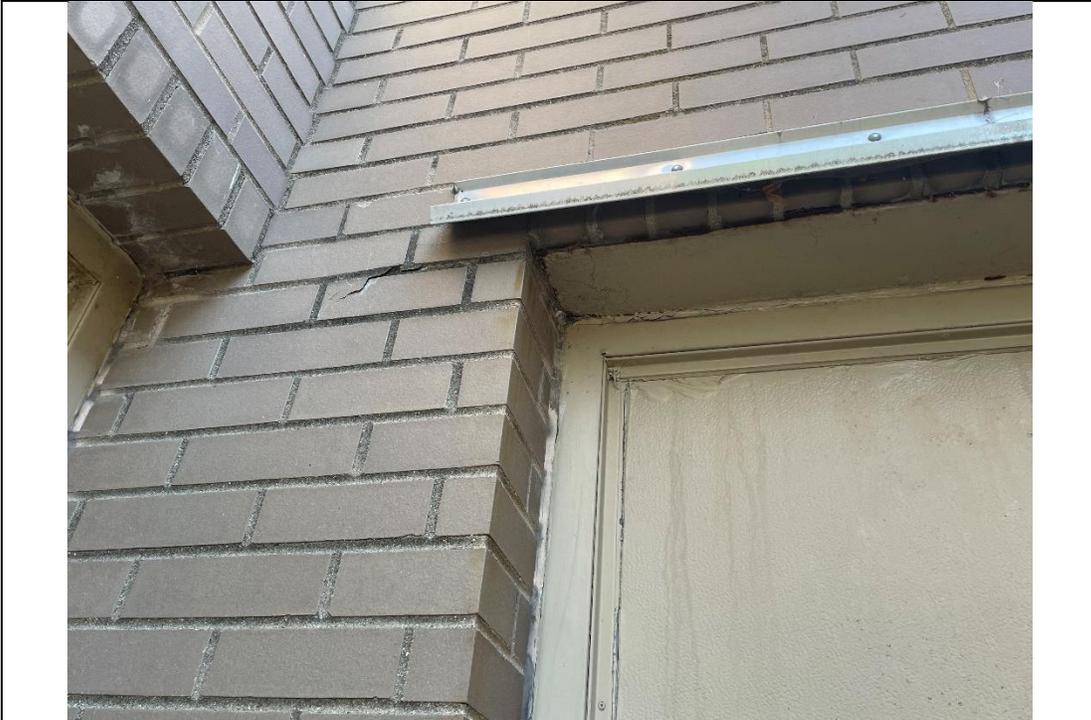
Description	Photo showing pack-rusting lintel above an existing east addition near the south-east corner wall opening infill that has cracked the brick at each side of the lintel.	<b>9</b>
Date	06/01/2023

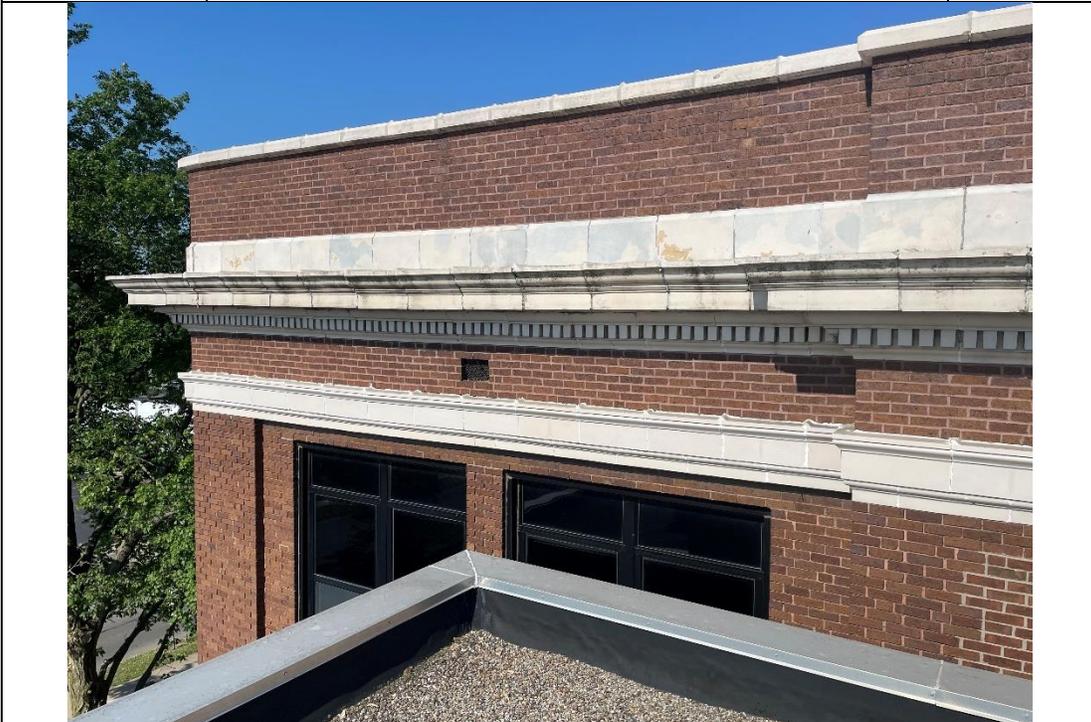
Description	Photo of south end of exterior side of east parapet of original 3-story school building showing the bow in the top of wall and the separation and displacements of the terra cotta decorative overhang blocks.	<b>10</b>
Date	06/01/2023

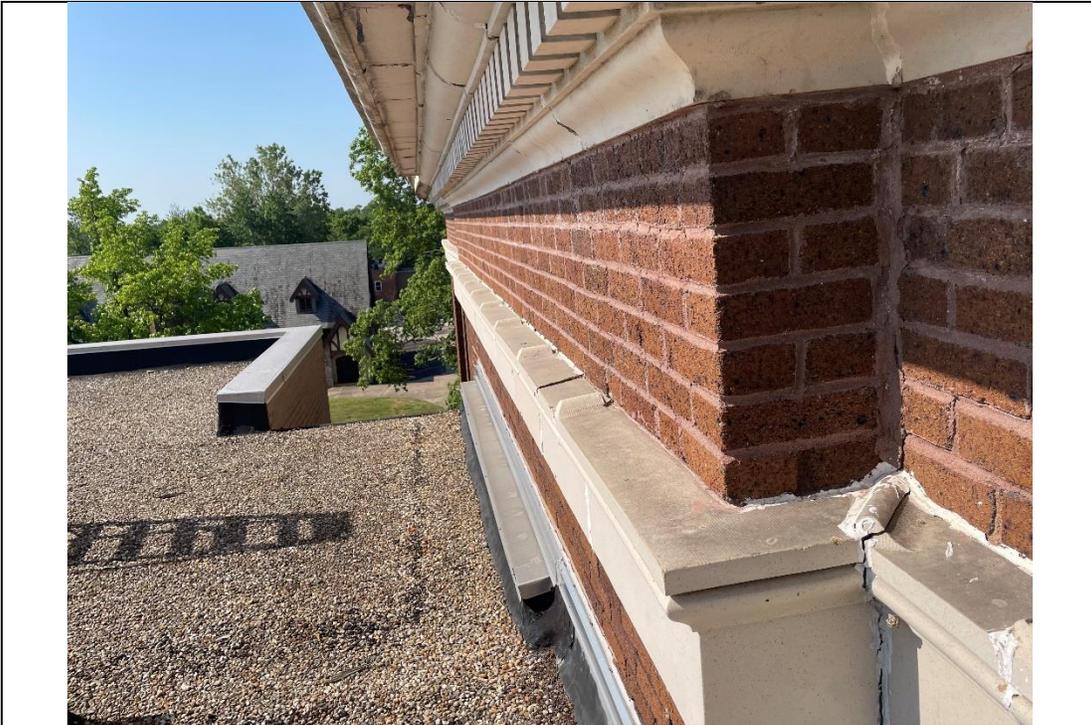
Description	Photo looking down exterior side of east parapet of original 3-story school building showing cracking and separation in the brick wall and terra cotta decorative blocks.	<b>11</b>
Date	06/01/2023

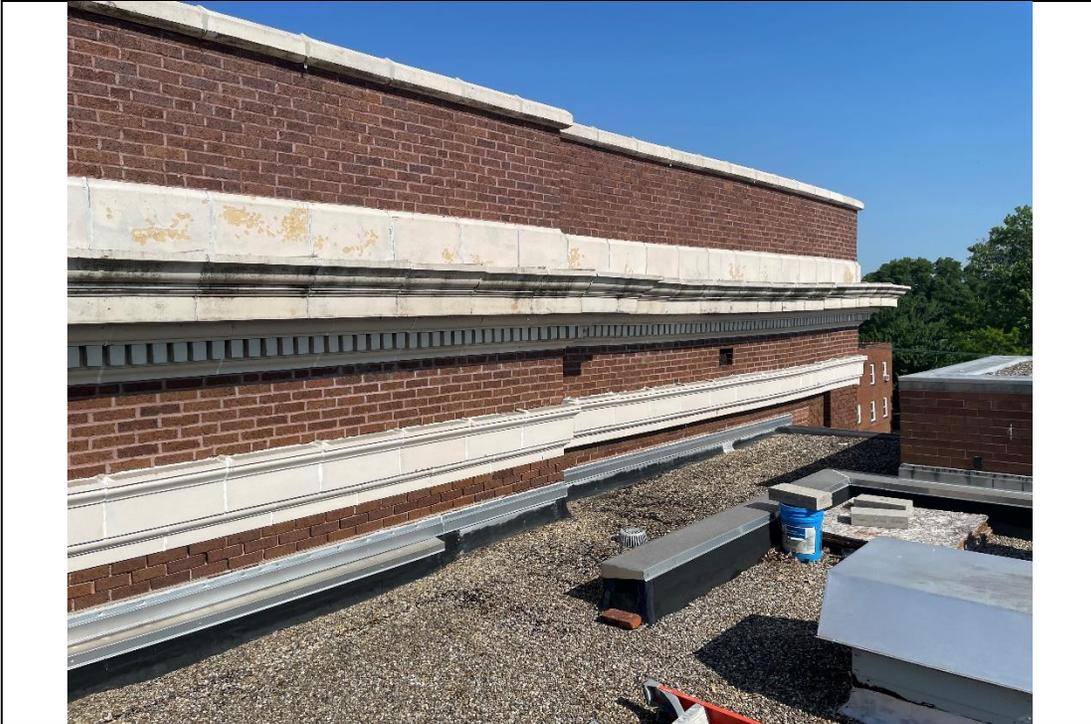
Description	Photo of north end of exterior side of east parapet of original 3-story school building showing the bow in the top of wall and the separation and displacements of the terra cotta decorative overhang blocks.	<b>12</b>
Date	06/01/2023

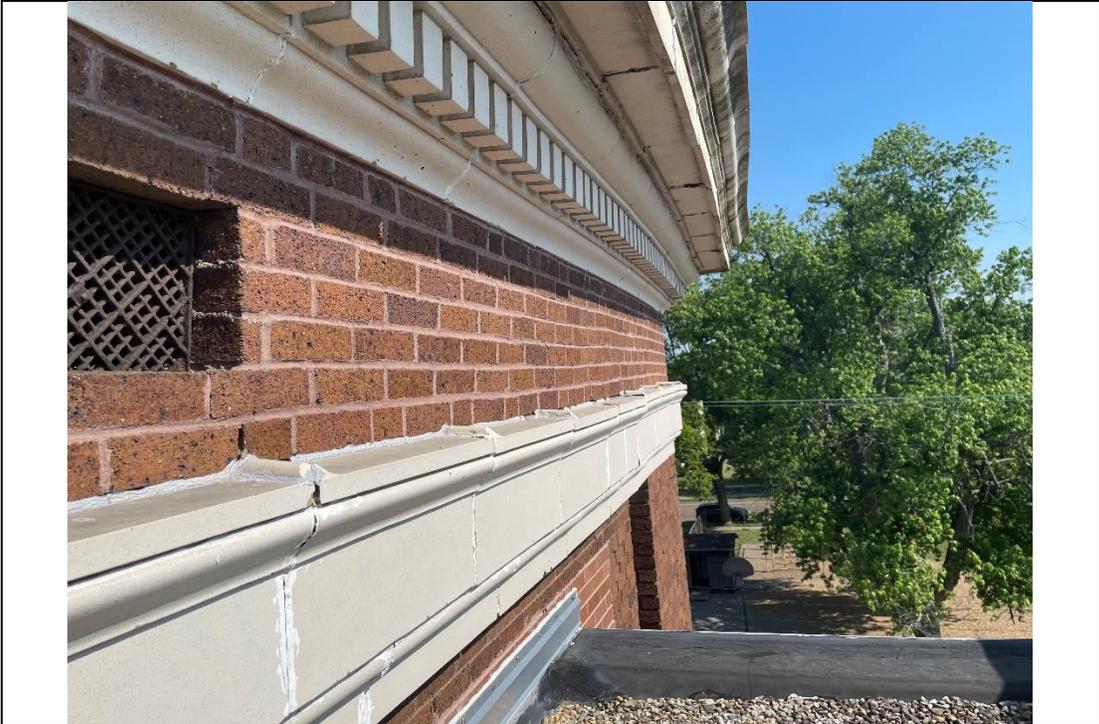
Description	Photo looking down exterior side of east parapet of original 3-story school building showing cracking and separation in the brick wall and terra cotta decorative blocks.	<b>13</b>
Date	06/01/2023

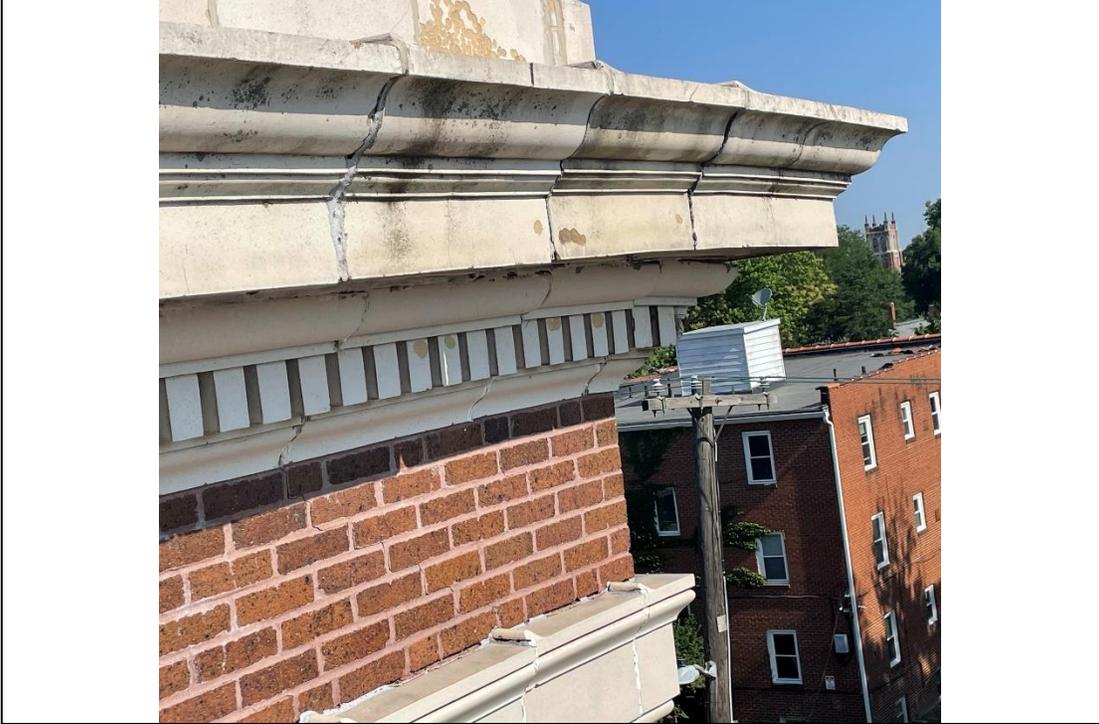
Description	Photo showing north-east corner of exterior side of parapet showing stairstep cracks in the brick wall and separation and displacements of the terra cotta decorative blocks.	<b>14</b>
Date	06/01/2023

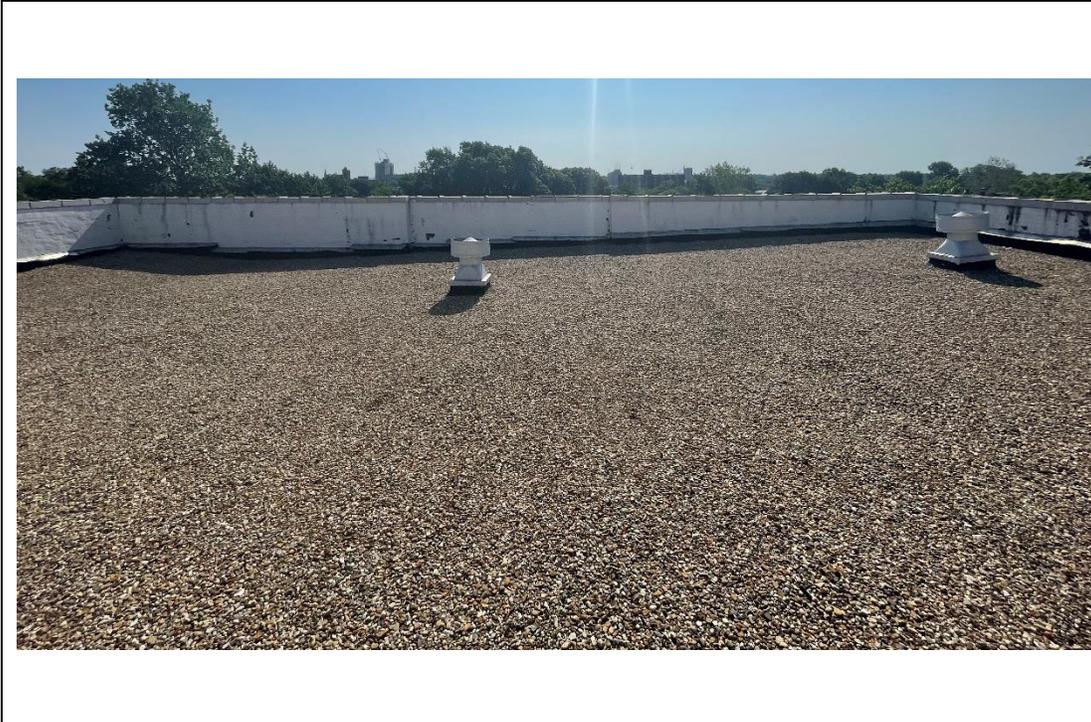
Description	Photo showing the roof of the original 3-story school building looking at the east parapet wall. Note the profile of the roof that slopes down towards the north.	<b>15</b>
Date	06/01/2023

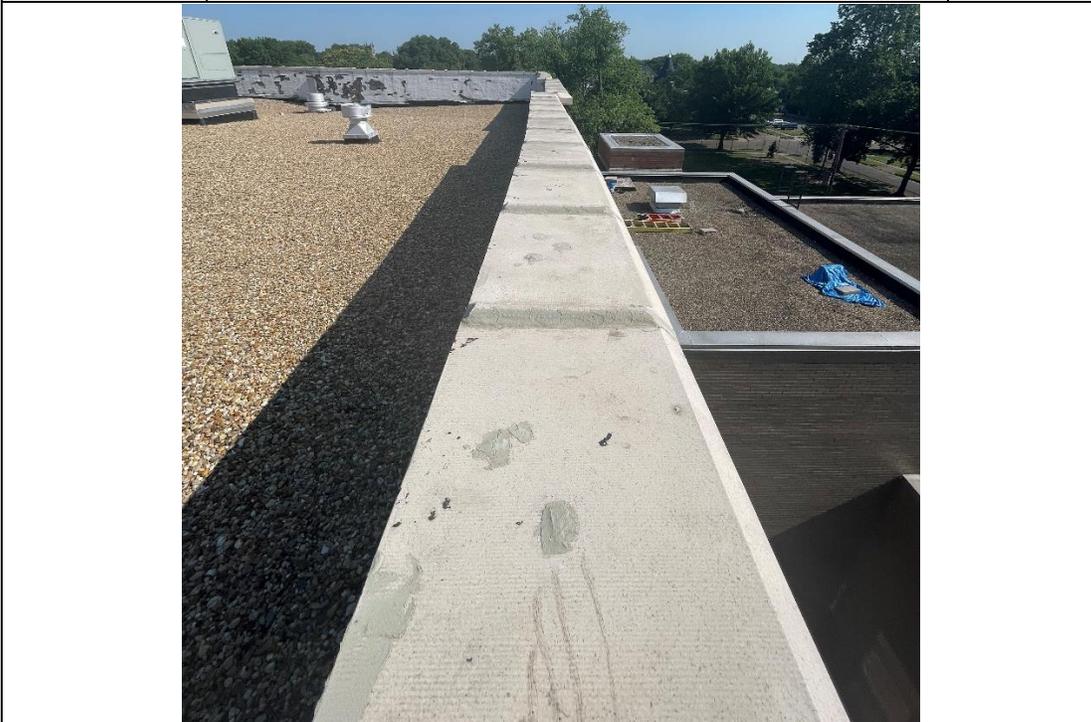
Description	Photo looking down the top of the east parapet showing the bowing out of the top of the parapet wall which is worse near the north corner.	<b>16</b>
Date	06/01/2023

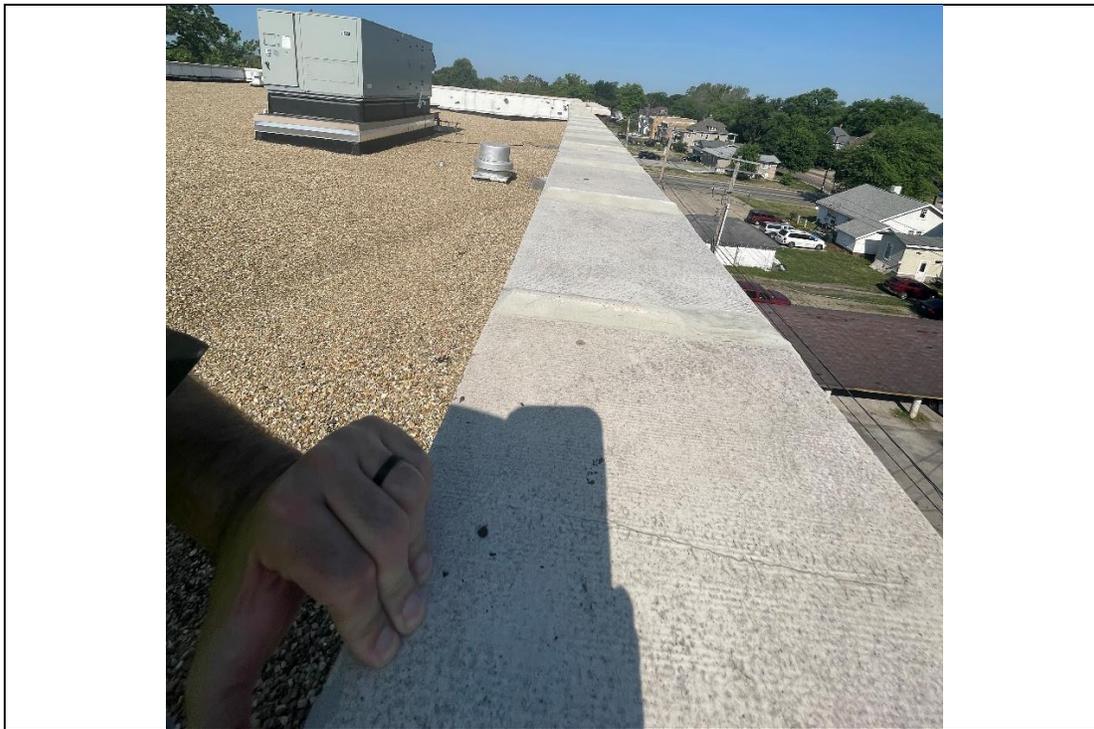
Description	Photo looking down the top of the north parapet showing the bowing out of the top of the parapet wall which is worse near the roof drain scuppers.	<b>17</b>
Date	06/01/2023

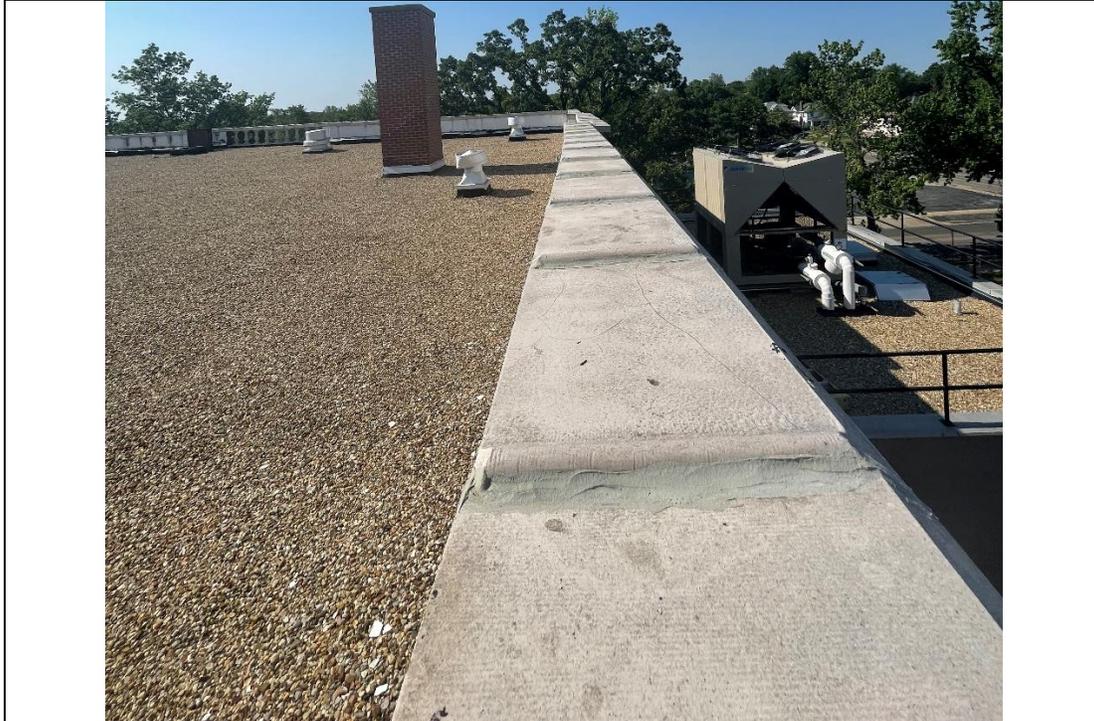
Description	Photo looking down the top of the west parapet showing the bowing out of the top of the parapet wall. Note the west wall parapet bowing is not as bad as the east wall.	<b>18</b>
Date	06/01/2023

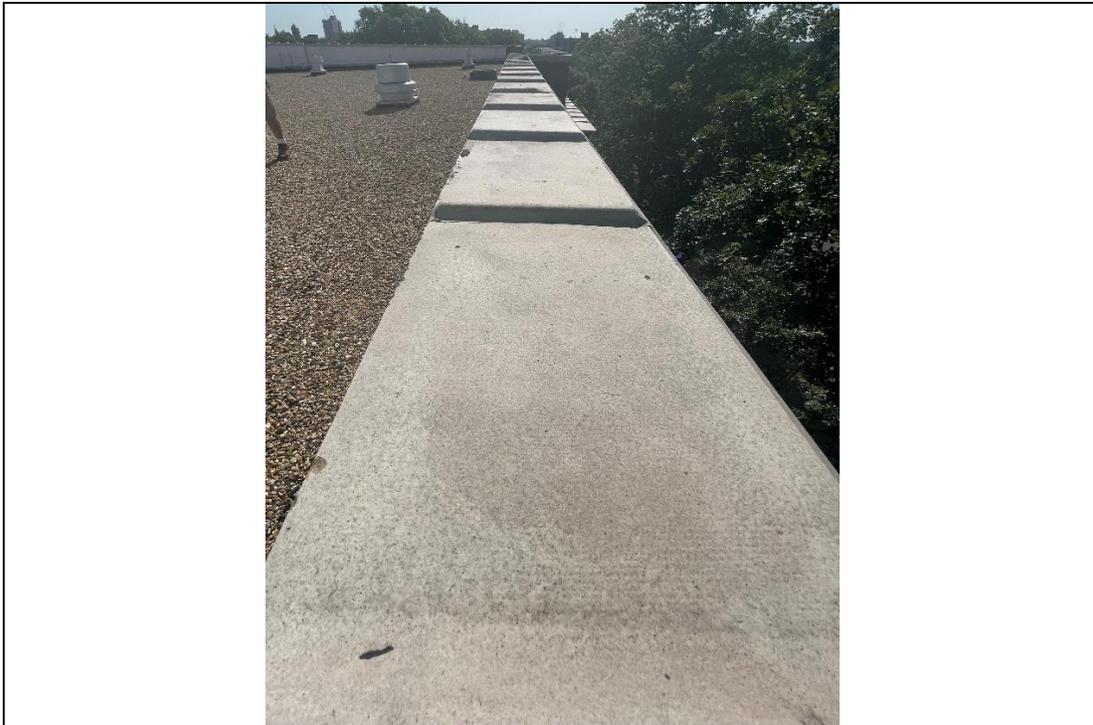
Description	Photo looking down the top of the south parapet showing the bowing out of the top of the parapet wall. Note the south wall parapet bowing was less than all other walls.	<b>19</b>
Date	06/01/2023

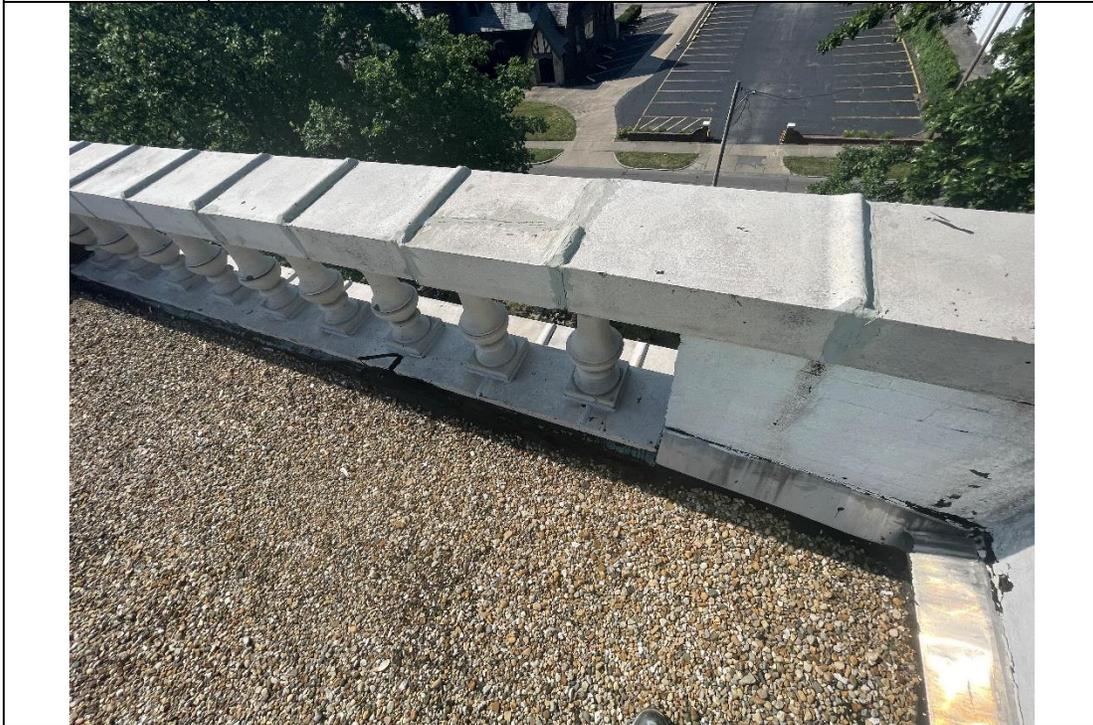
Description	Photo showing a parapet terra cotta coping piece on the south parapet that was broken and had an attempted repair.	<b>20</b>
Date	06/01/2023

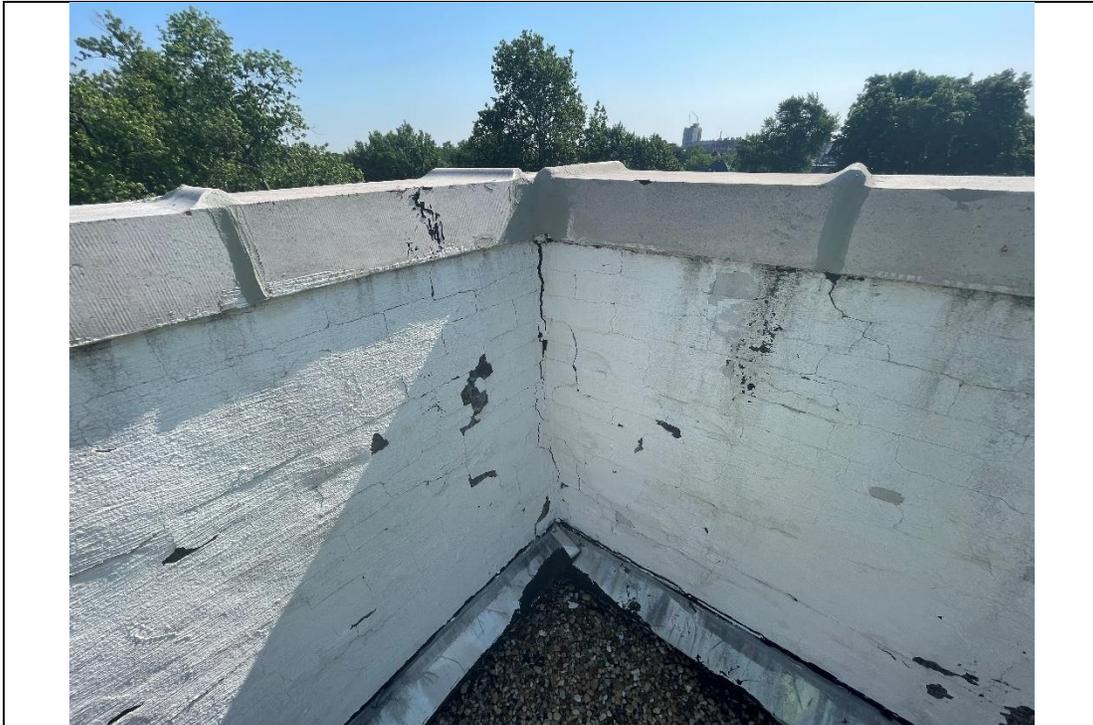
Description	Photo showing the interior side of the north-east parapet corner showing a crack and gap in the brick wall. The terra cotta coping joints had already had recent repair attempt.	<b>21</b>
Date	06/01/2023

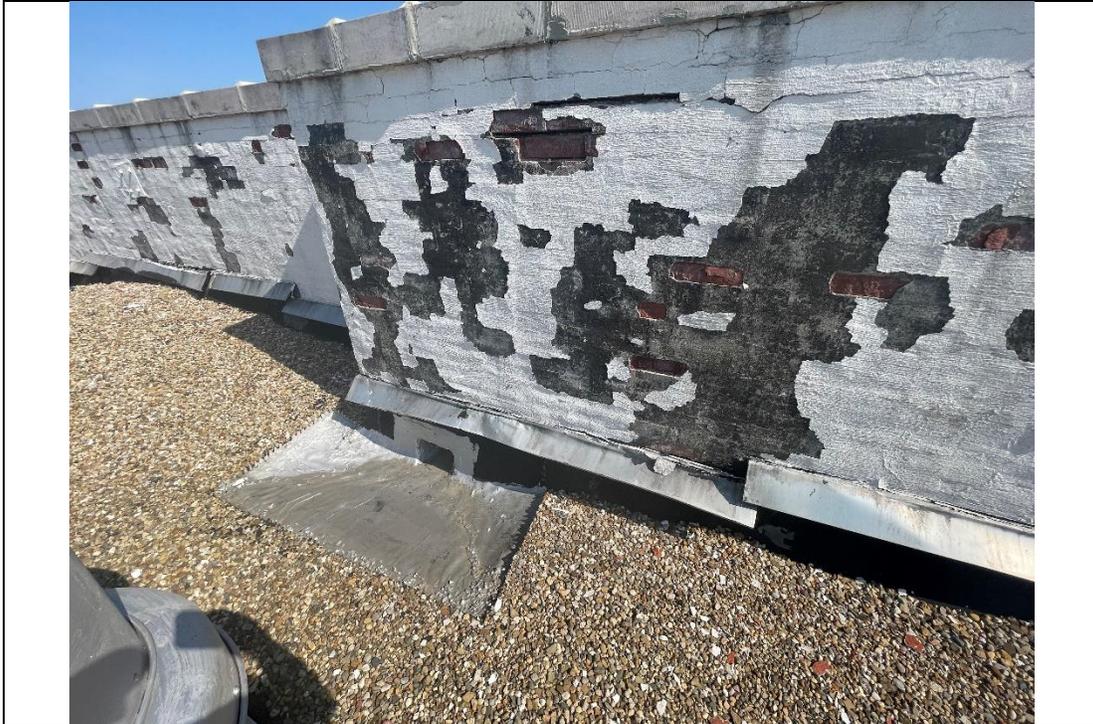
Description	Photo showing the deteriorated coatings on the interior side of the parapet that was worst near the north parapet scupper drain openings. Note the roof membrane only extends up a couple of brick courses, typical.	<b>22</b>
Date	06/01/2023

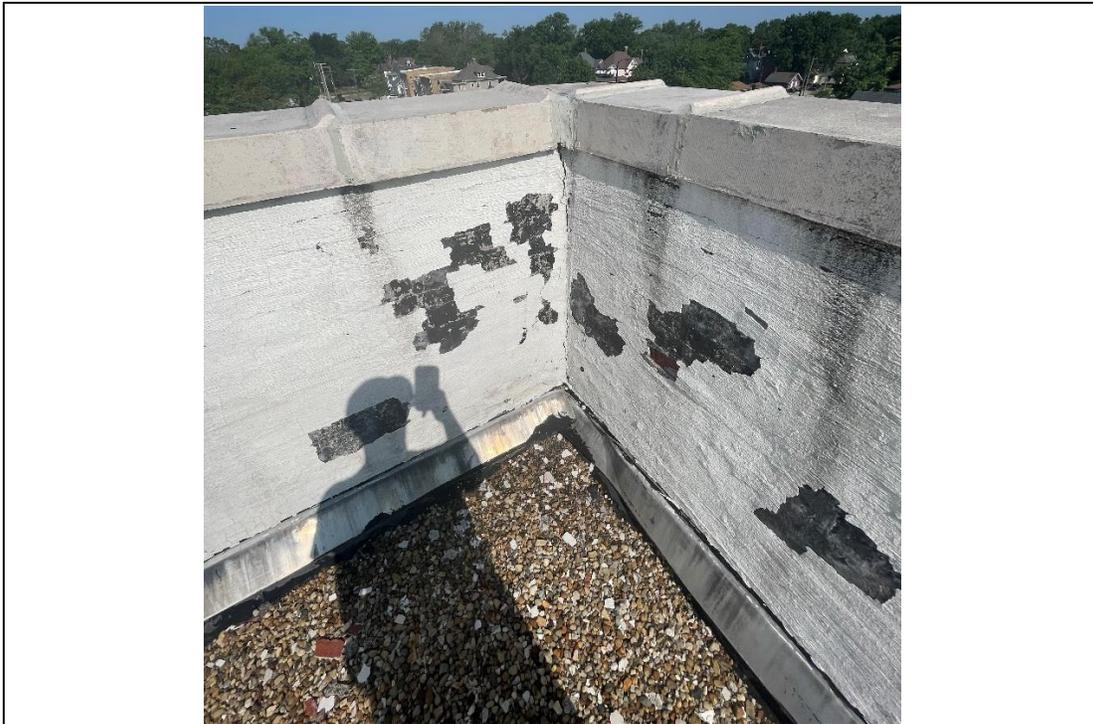
Description	Photo showing the interior side of the north-west parapet corner showing a crack and gap in the brick wall. The terra cotta coping joints had already had recent repair attempt.	<b>23</b>
Date	06/01/2023

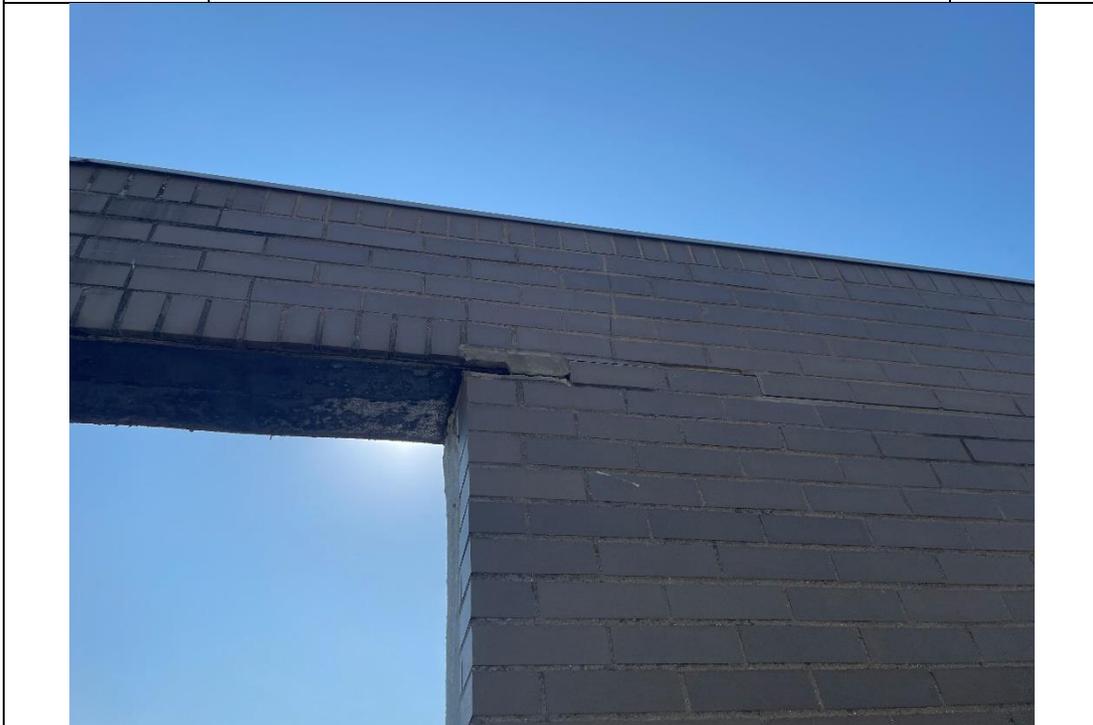
Description	Photo showing a pack-rusted lintel beam above an opening in the screen wall that surrounds the roof top equipment above the east addition. Note the brick cracking.	<b>24</b>
Date	06/01/2023
