RE: Structural Evaluation Observations and Recommendations of the Kaleidoscope School Building at 520 W. Wood St. in Decatur, Illinois.

On June 1, 2023, Structural Engineer Kyle Hannel, P.E. of Klingner & Associates performed a visual structural evaluation of the Kaleidoscope School Building at 520 W. Wood St. in Decatur, Illinois. We were informed that there were recent concerns with the structural integrity of the original building's exterior walls and parapets. The focus of our inspection and evaluation was limited to the exterior walls and parapets of the Kaleidoscope School building. The original 3-story portion of this school building was built in 1913 and was named New Wood Street School. In the 1970's and 1980's 2-story additions were added to the east and west side of the original school building and was named French Elementary School. Access to the existing building plans that the school district had available were made available to us to scan so we could have a copy to aid in our evaluation just prior to performing our inspections. We have included scans of a couple of important applicable drawings as attachments to this report. The Decatur Public School District had re

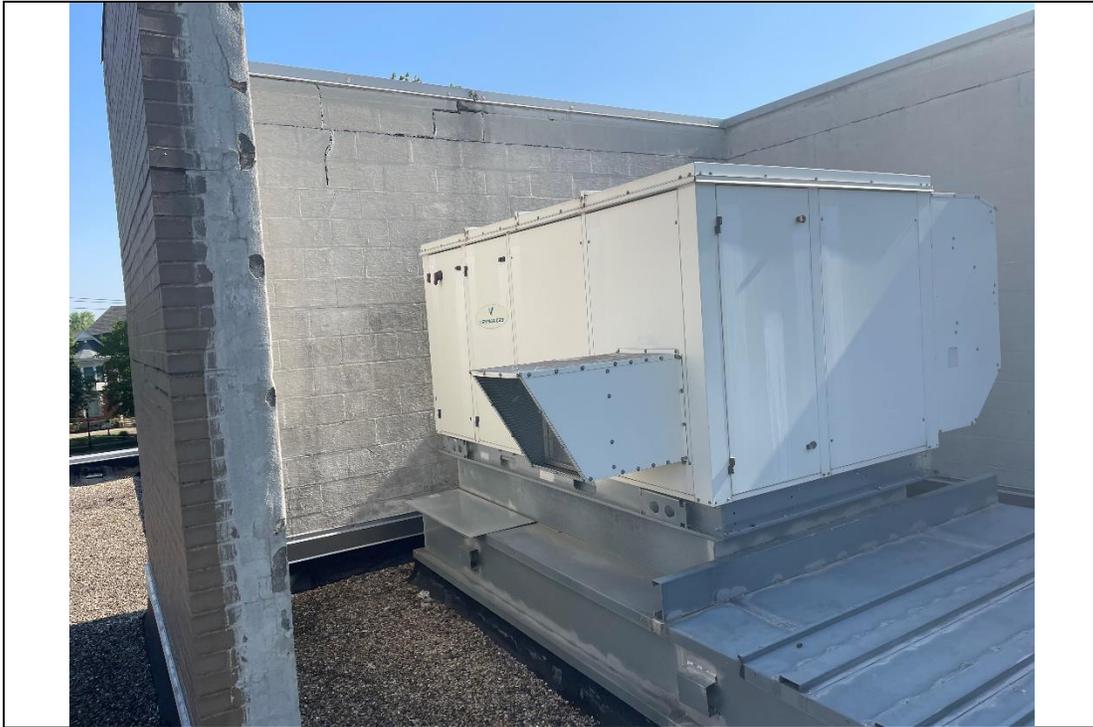
3. While the focus of the evaluation was on the original 3-story school building, we also observed a few locations of exterior wall deterioration on the 2-story east building addition. Two exterior wall door openings on the first floor near the south-west portion of the east building had lintels with pack-rusting deterioration that had cracked the brick veneer at each end of the lintel bearing. Similarly, there is a large lintel beam for an opening on the west side of the roof-top screen wall that surrounds the east addition roof top equipment that has severe pack-rust deterioration and brick veneer deterioration at the lintel bearing. The upper courses of concrete masonry unit (cmu) block and brick veneer of the east roof-top screen walls have mortar joint cracking that stair steps near the wall corners and lintels bearings. See attached Photos #8 thru #9 and #24 thru #25.

Description	Photo showing brick cracking near the top of the cmu/brick screen wall that surrounds the roof top equipment above the east addition.	<b>25</b>
Date	06/01/2023

**Klingner recommends repairing or replacing all pack-rusting deteriorated door opening lintels in the east addition exterior walls and roof top screen wall and tuckpointing all deteriorated brick and cmu mortar joints. Klingner recommends using galvanized steel lintels if replacing the door lintels to prevent future pack-rusting deterioration.**

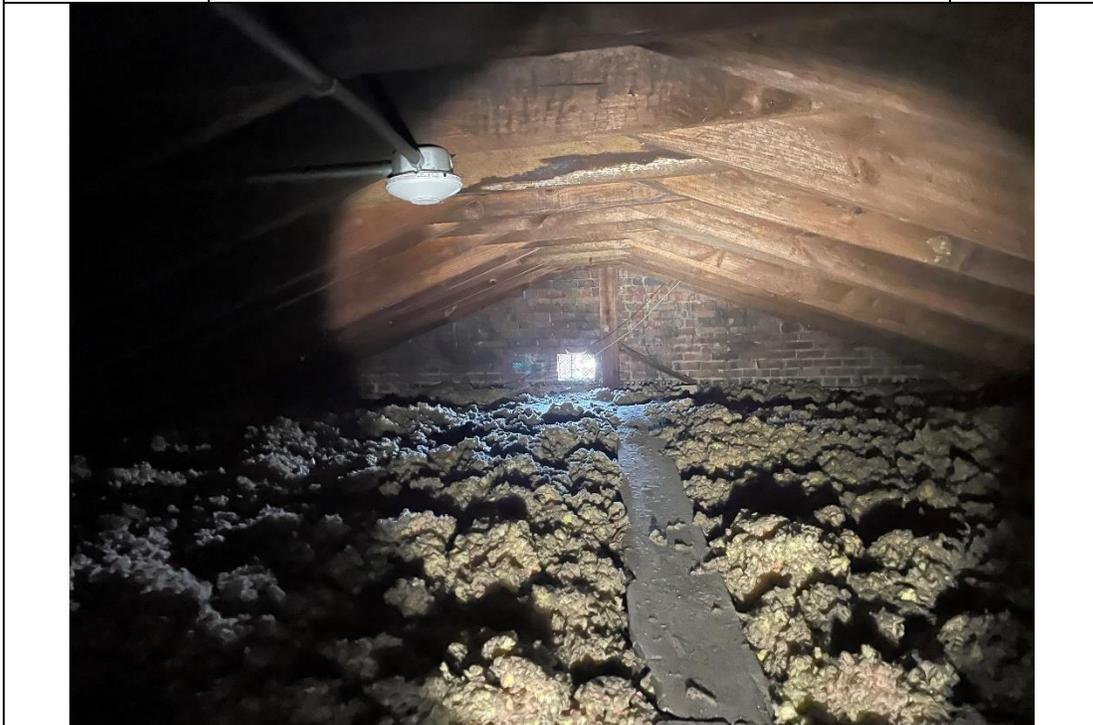
1. The timber roof framing of the original 3-story school building runs in the north south direction and is supported by load bearing interior brick walls at 1/3 points and is pocketed into and supported by the north and south exterior load bearing brick wall. The top of the interior load bearing brick walls stops at the third-floor ceiling level and a short wood stud wall is built up above the brick walls to support the roof joists and built-up truss top chords. The attic space height is limited and gets smaller as the roof slopes down to the north. The roof decking and framing was observed to not be attached or tied to the east and west walls or parapets. A gap between the east-most roof framing and wood decking and the interior face of wall was observed and measured to be up to 3 ½" near the middle of the east wall. The wood deck and the roof framing that was pocketed into the north and south exterior walls had portions with signs of water deterioration. A few locations of pocketed roof framing on the south end were observed to have steel straps or shims added in an attempt to prevent the wood framing from pulling out of the pocket. While water damage near the bearing pockets was observed in the south wall it was worse in the north wall, especially near the roof drain scupper penetrations. Previous attempts to sister some of the water deteriorated roof joists was observed near the north wall bearing. See attached Photos #26 thru #33.

Description	Photo looking east in the attic space in the south-most roof framing bay. Note the limited attic height/space.	<b>26</b>
Date	06/01/2023

**See similar recommendations for exterior wall Observation #2 and exterior parapet Observation #4 above. Additionally, Klingner recommends securing the pocketed connections of the north and south wall roof framing with straps or brackets to prevent future pull-out of the pockets. Klingner also recommends replacing or repairing any water deteriorated portions of roof framing. Klingner also recommends replacing the waterproofing on the interior side of the roof parapets.**

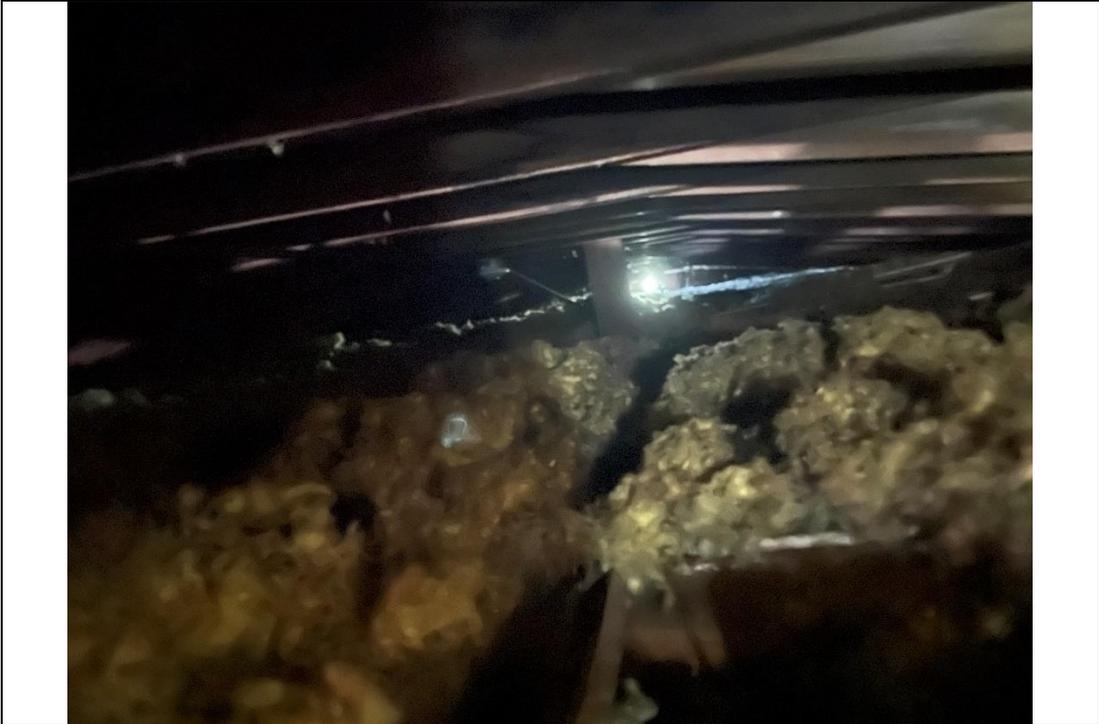
Description	Photo looking west in the attic space in the north-most roof framing bay. Note the limited attic height/space.	<b>27</b>
Date	06/01/2023

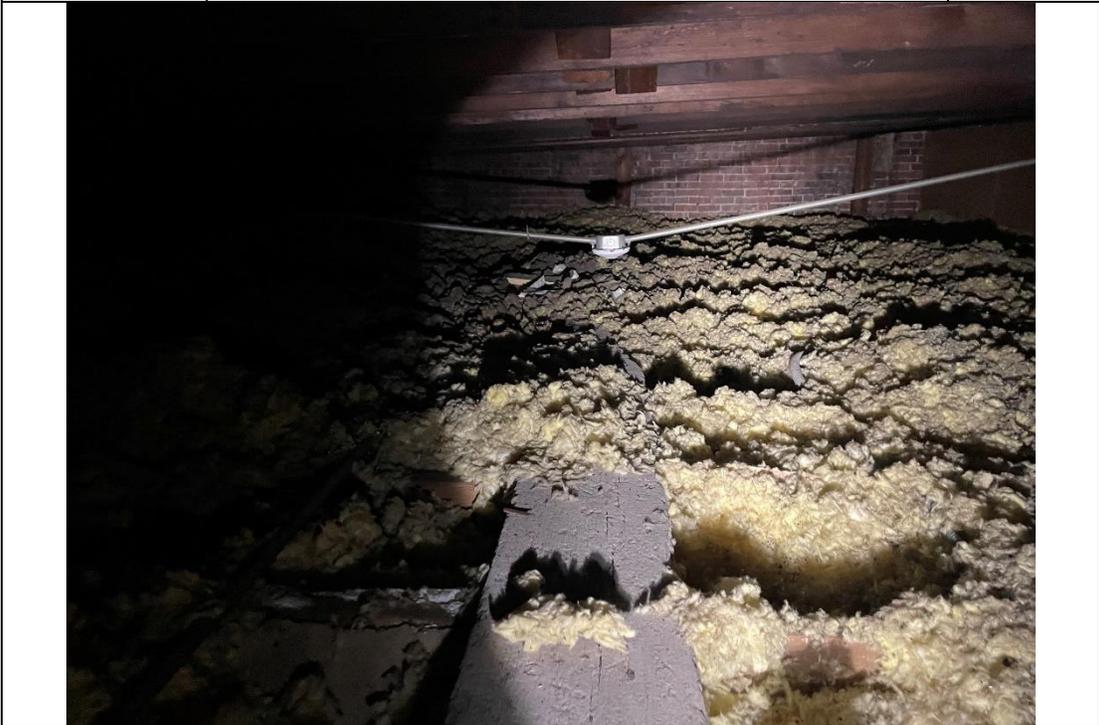
Description	Photo looking east in the attic space in the middle roof framing bay. Note the limited attic height/space.	<b>28</b>
Date	06/01/2023

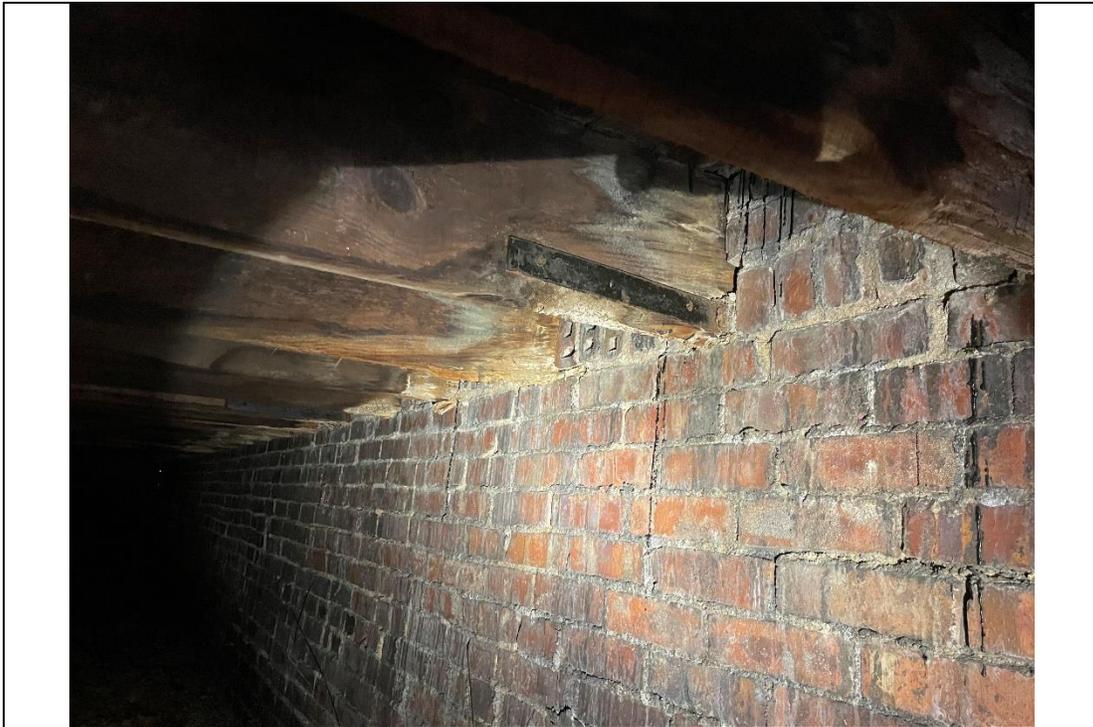
Description	Photo in the attic space showing the roof joists pocketed into the brick wall of the south wall. Note a few joists at steel straps/shims added previously.	29
Date	06/01/2023

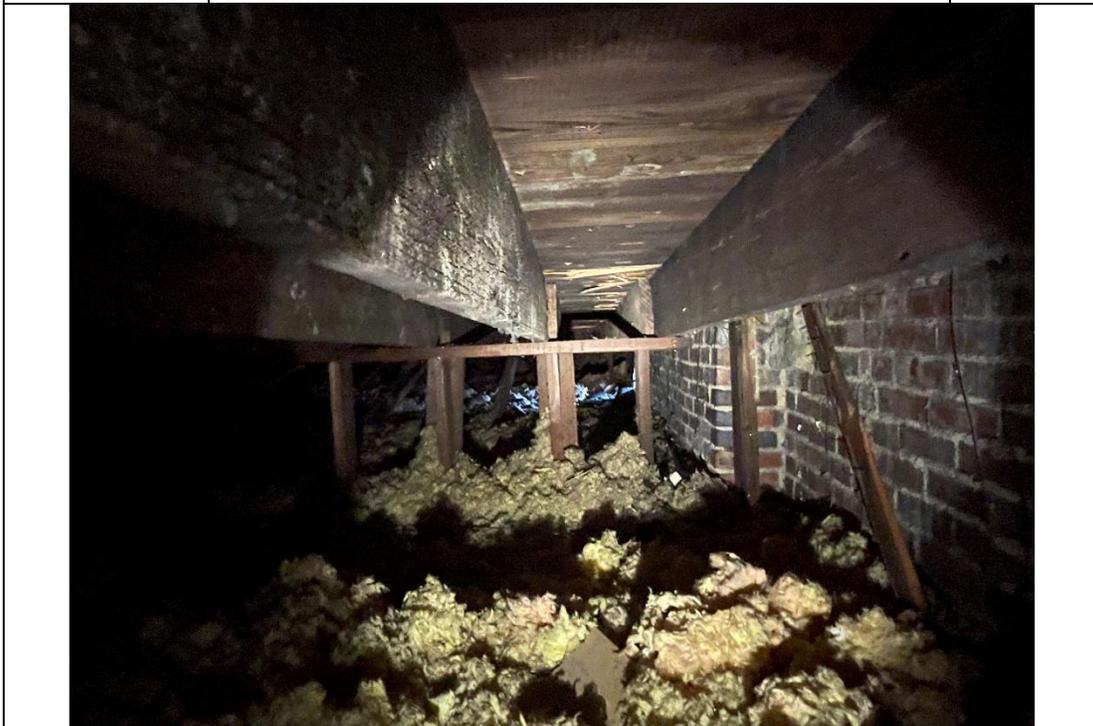
Description	Photo looking north along the east wall showing deteriorated roof joists and split wood decking members.	30
Date	06/01/2023

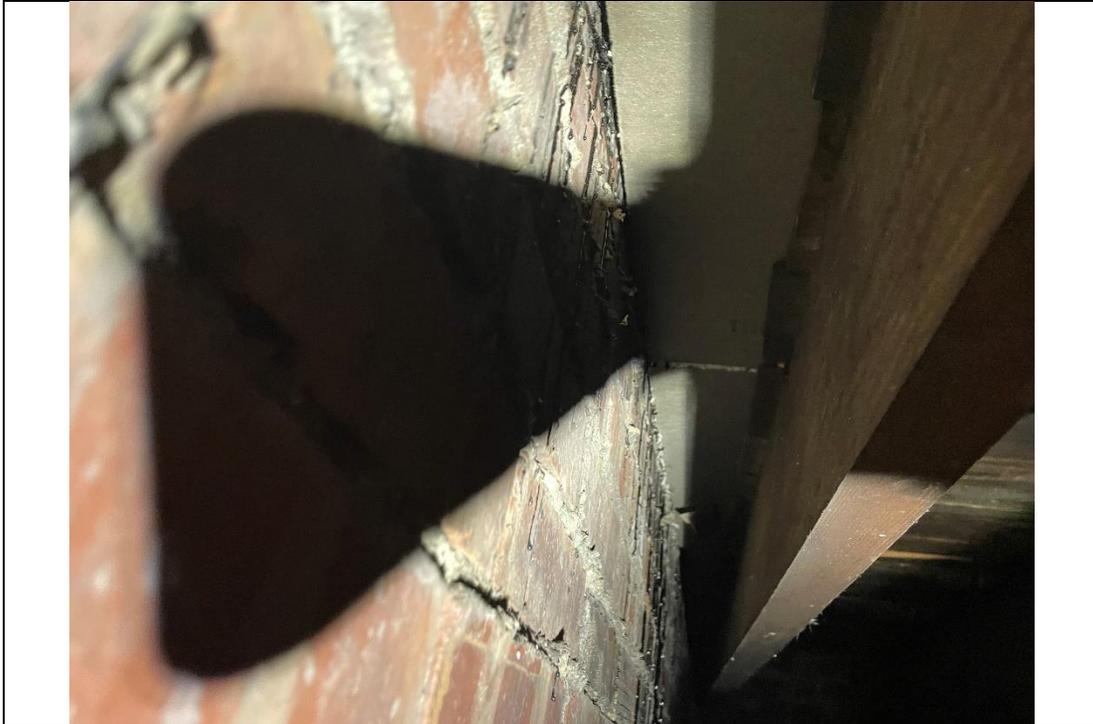
Description	Photo in the attic looking at the current separation (measured in the range of 3 1/2") between the interior face of brick wall and the edge of roof joist and roof decking. Note that nothing ties the roof decking or joists to the east wall.	<b>31</b>
Date	06/01/2023

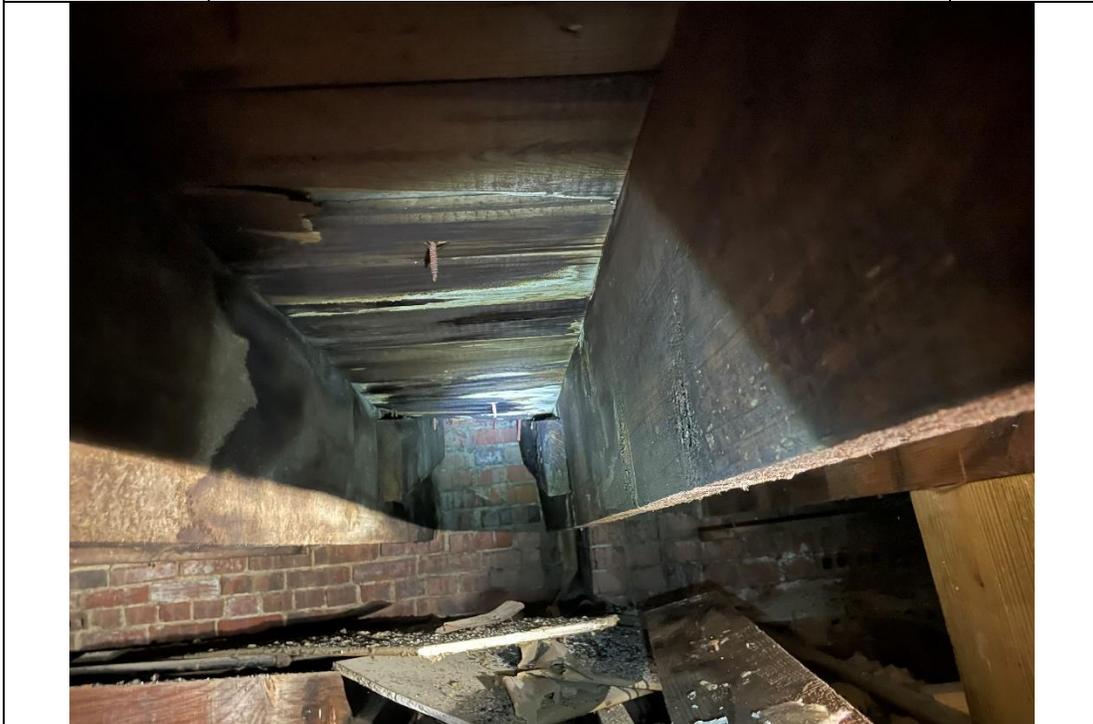
Description	Photo in the attic space showing the roof joists pocketed into the brick wall of the north wall. Note the water damage deterioration of the joists/decking and previous sister repairs	<b>32</b>
Date	06/01/2023

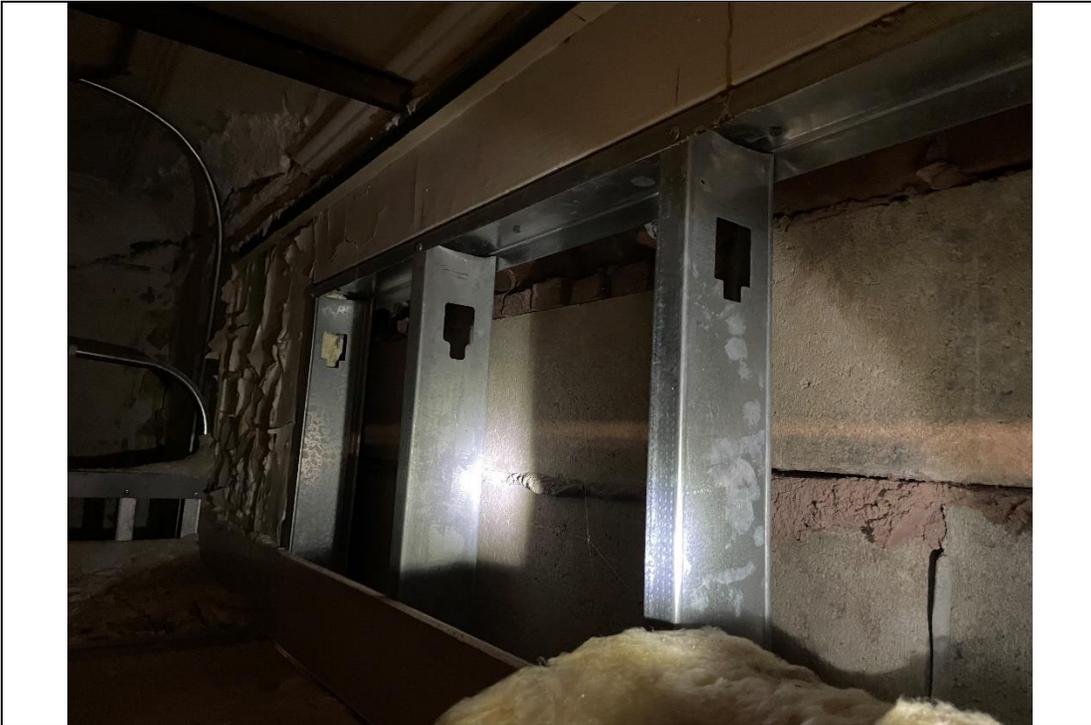
Description	Photo along the east wall in the ceiling space of the 3 <sup>rd</sup> floor showing a portion of exposed interior face of wall with unbonded mortar joints in the block and bricks.	<b>33</b>
Date	06/01/2023

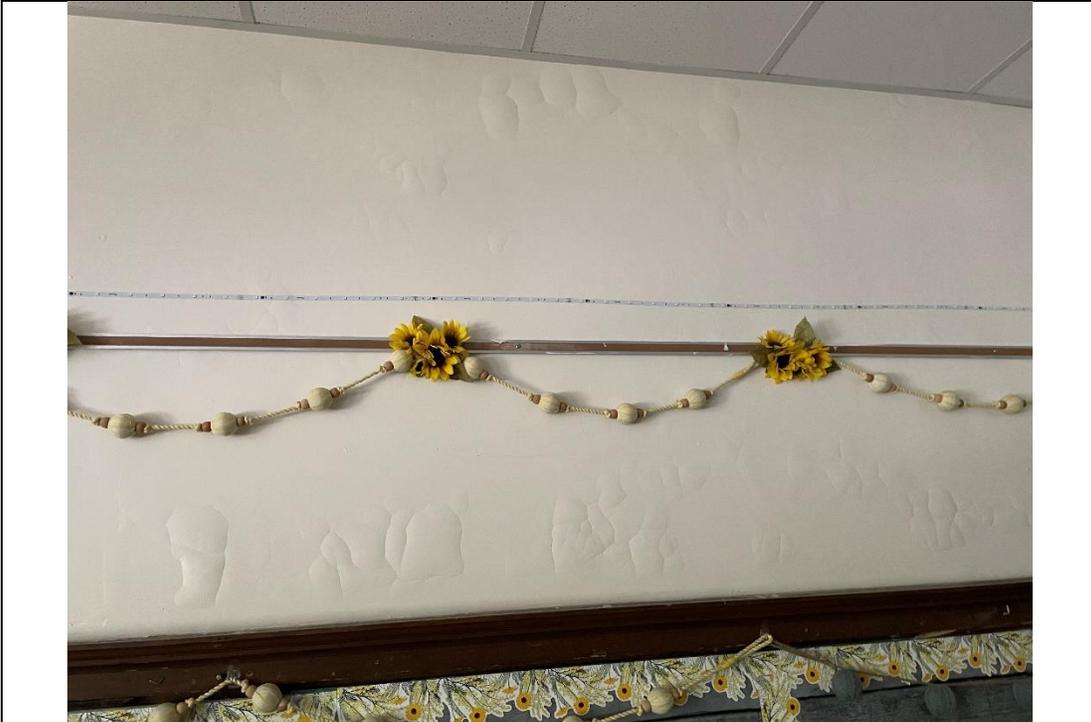
4. The exterior walls parapets of the original 1913 3-story school building are made up of multi-wythe brick parapets with portions of large terra cotta decorative block strips cantilevered out on the exterior side of the parapets. The parapets have a terra cotta cap stone. The top of parapet height above the roof line ranges from 3'-0" to 6'-6" above the roof level. The roof membrane flashes into the lowest course of brick exposed above the roof membrane and ballast and the flashing steps down to approximately follow the slope of the roof line. The inside face of parapet appears to have been coated and painted to attempt to prevent moisture infiltration of the parapet. However, the coating and paint on the inside portion of parapet is deteriorated and missing in numerous locations and appears to be allowing moisture to penetrate the parapet walls. Moisture damage to the drywall near the top of wall or ceiling tiles near the exterior wall in multiple third floor classrooms was observed. The deterioration of the paint and moisture coating appears to be the worst near the roof drain scuppers on the north parapet. Cracks were observed on the interior side of the north-east and north-west parapet corners. The north-east parapet corner cracks were larger than the north-west parapet corner cracks. The parapets are leaning outward and bowing outward in multiple locations. The worst of the parapet bowing and leaning observed was along the east parapet and specifically the north end and corner of the east parapet. The west and north wall parapet bowed outward near the quarter points. The south wall parapet was the shortest parapet and showed the least signs of leaning or bowing. See attached Photos #1 thru #7, #10 thru #23, and #34.

Description	Photo showing a water damaged drywall portion of top of wall of an exterior wall of the 3 <sup>rd</sup> floor. Likely means water is penetrating into the exterior walls at the roof or parapet.	<b>34</b>
Date	06/01/2023

**Similar to exterior wall Observation #2 above, Klingner recommends partial demolition and rebuild of the top of the east wall and parapet. While rebuilding the top of east wall Klingner recommends considering not putting back the decorative terra cotta cantilever strip portions of wall and only using brick or cmu block with brick veneer. The terra cotta can be reinstalled if proper reinforcement is provided, but this would be more costly. Klingner also recommends using tie-back anchors on both the east exterior wall and west exterior wall to tie the walls back to adequately braced and blocked roof framing.**
